# the play inspection company

## **Operational Inspection**

Tattenhall & District Parish Council

Tattenhall Park

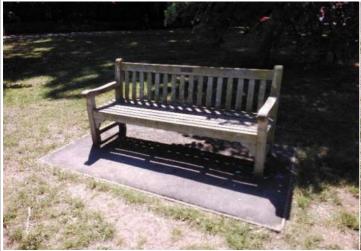
### 8 - Low Risk (Finding 1)

**Finding:** There are trip hazards at the edges of the surface Action: Reinstate surrounding surface levels to remove the trip points

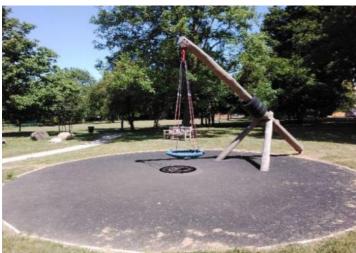
#### 6 - Low Risk (Finding 1)

**Finding:** There are gaps opening between the surfacing and **Action:** Monitor for any further deterioration and repair as the edging surround or between the joints in the surfacing required

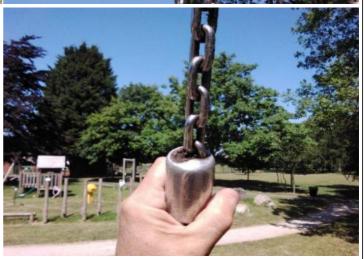
Finding: There is some notable evidence of chain wear

Action: Monitor for any further deterioration and replace when 40% worn

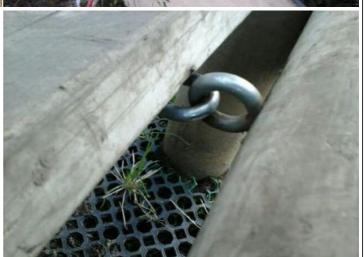
Finding: There is some Wear to the bridge chains

**Action:** Monitor for any further deterioration and replace when 40 % worn

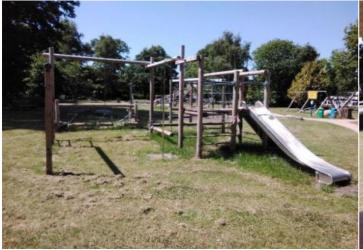
### 6 - Low Risk (Finding 6)

Finding: A number of fixing(s) have worked loose on the rope net

Action: Secure all loose fixings

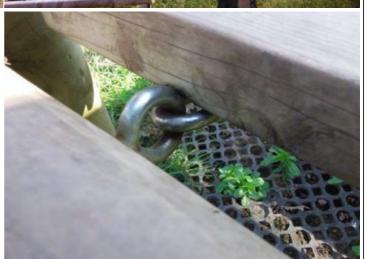
**Finding:** There is some wear to the shackles.

**Action:** Monitor for any further deterioration and replace when 40% worn

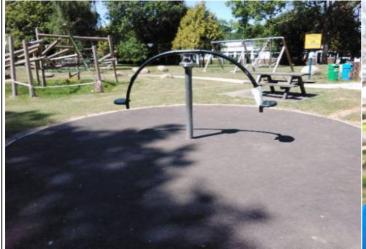
**Finding:** There are missing spaces on the mount plate or they have been over tightened which is causing them to wear

Action: Adjust or install missing components

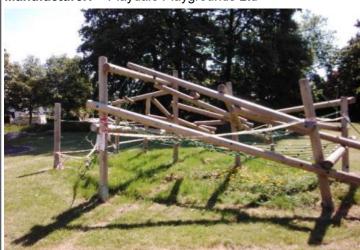
#### 8 - Low Risk (Finding 1)

Finding: The grass mats are silted up and the soil is compacted; this may have an effect on the impact absorbing ensure the correct surface qualities are maintained for the properties of the surface

Action: Consider HIC testing impact absorbing properties to equipment and replace as required

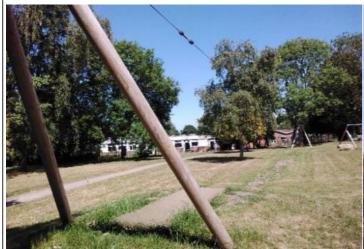
**Finding:** We have completed a visual inspection of the cable and fixing points from ground level, however it is not possible to fully inspect the cable and fixings without either hiring equipment to gain access or removing the cable and inspecting at ground level. We recommend that the main cable and fixing security is thoroughly inspected at least in accordance with the manufacturers recommendations to check for damage, security or internal rusting, this will help to ensure the continued safe use of the equipment

**Action:** Inspect in accordance with the manufacturers recommendations

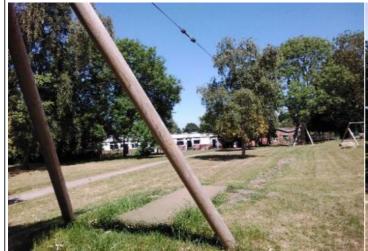
# 6 - Low Risk (Finding 7)

**Finding:** The tree canopy overhangs the equipment and is less than 2.0m away

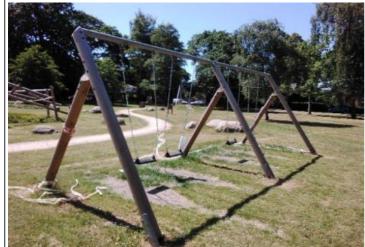
# 6 - Low Risk (Finding 3)

Finding: There is some notable evidence of chain wear

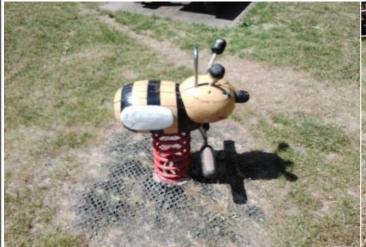
# 6 - Low Risk (Finding 1)

Finding: A number of fixing(s) have worked loose securing Action: Secure all loose fixings the foot rests

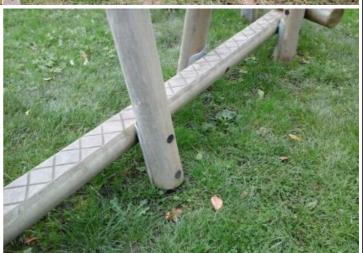
**Finding:** A number of fixing(s) have worked loose on the majority of the log weave posts

**Action:** Secure all loose fixings

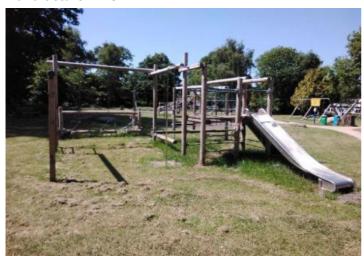
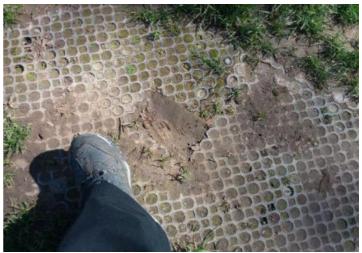
4 - Very Low Risk (Finding 2) - Marked as complete on 2-June-2020

**Finding:** The safety surface under or around this unit has been damaged

**Action:** Monitor for any further deterioration and repair as required

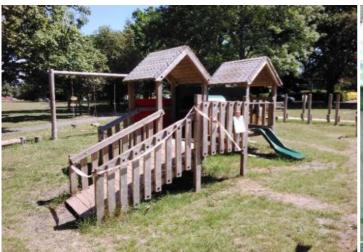
8 - Low Risk (Finding 1) - Marked as complete on 2-June-2020

**Finding:** There is algae or moss on the surface of the equipment
