## **Submission to assist Cheshire West & Chester investigation of the significant flooding event 20<sup>th</sup> January 2021**

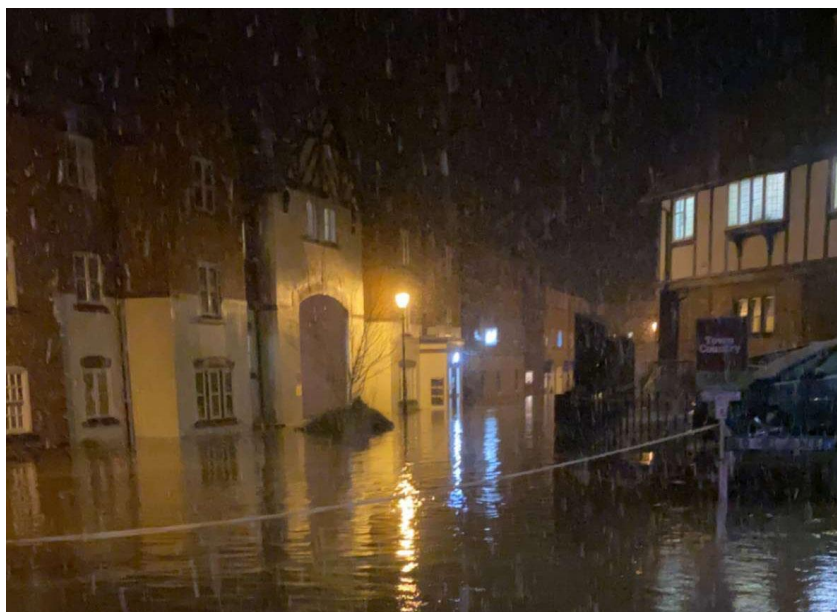
Figure 1 - Old Mill Place 10-11-2000

For the first time residential property was built at Old Mill Place, in 2000. In November 2000, a few weeks after completion and occupation, all 18 new properties, including the Old Mill itself, in Old Mill Place were flooded to a depth of approximately 1 meter ([Figure 1](#)). Subsequently, upstream works (by the Environment Agency, Bolesworth Estate, tenant farmers and Tattenhall Wildlife Group) and construction of a storm drain in the Mill Field were undertaken to mitigate flood risk.

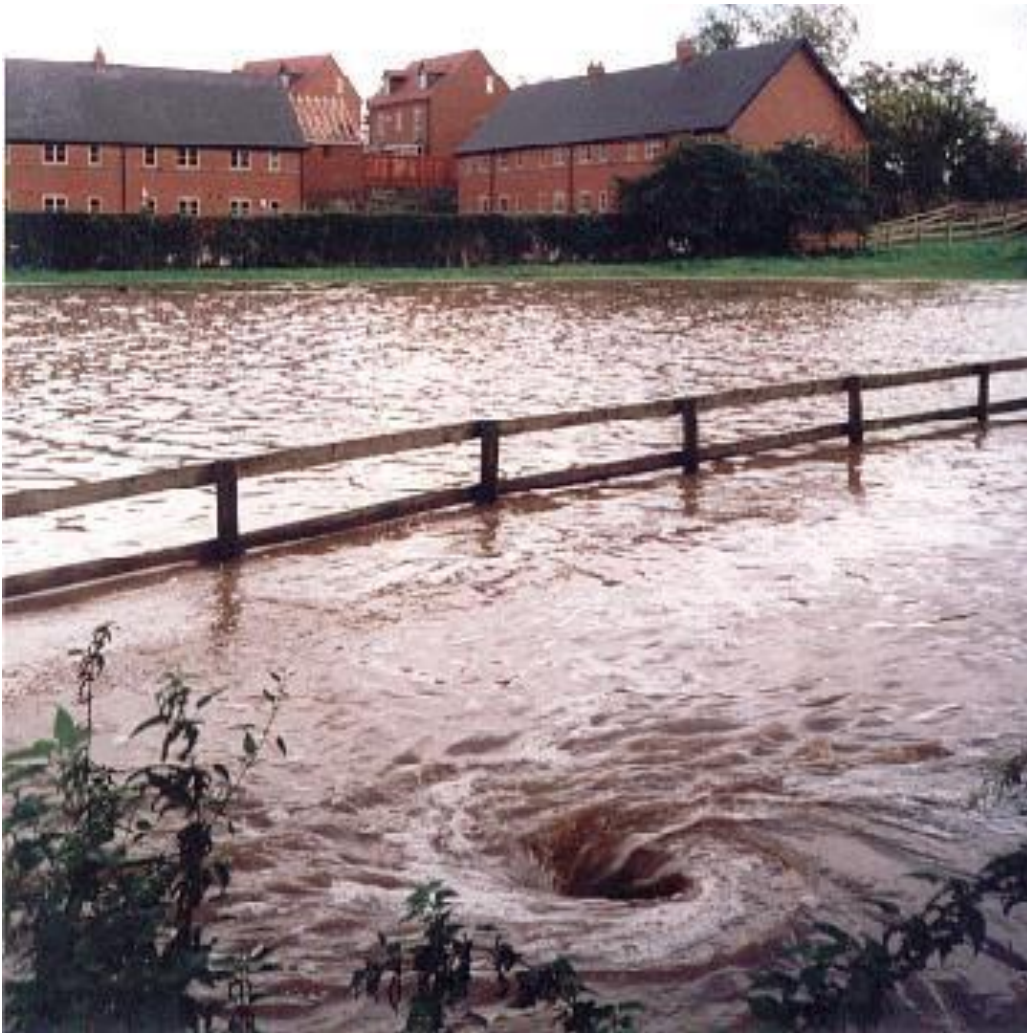
Figure 2 Old Mill Place 20-01-2021

In January 2021, all 18 properties in Old Mill Place were again flooded to a similar depth as in 2000 ([Figure 2](#)). Businesses have been significantly affected, damage to property has been extensive and 5 people were made homeless.

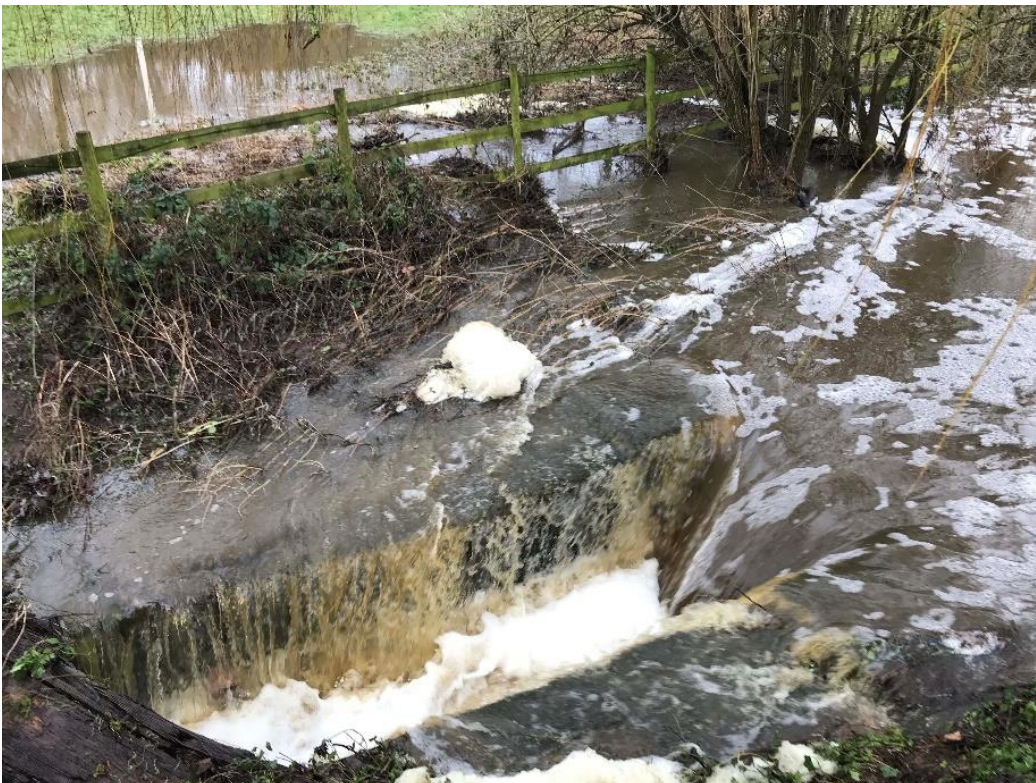
*Figure 3 Mill Brook at the High St. bridge 11-11-2000*

- Mill Brook under the High Street (the normal course of the brook) ([Figure 3](#), [Figure 4](#))
- A storm drain, constructed after the 2000 flood event, beside the War Memorial, running under the High Street and into Mill Brook downstream of the High Street bridge ([Figure 5](#))
- Directly into Old Mill Place
- Indirectly into Old Mill Place via High Street in front of the Barbour Institute

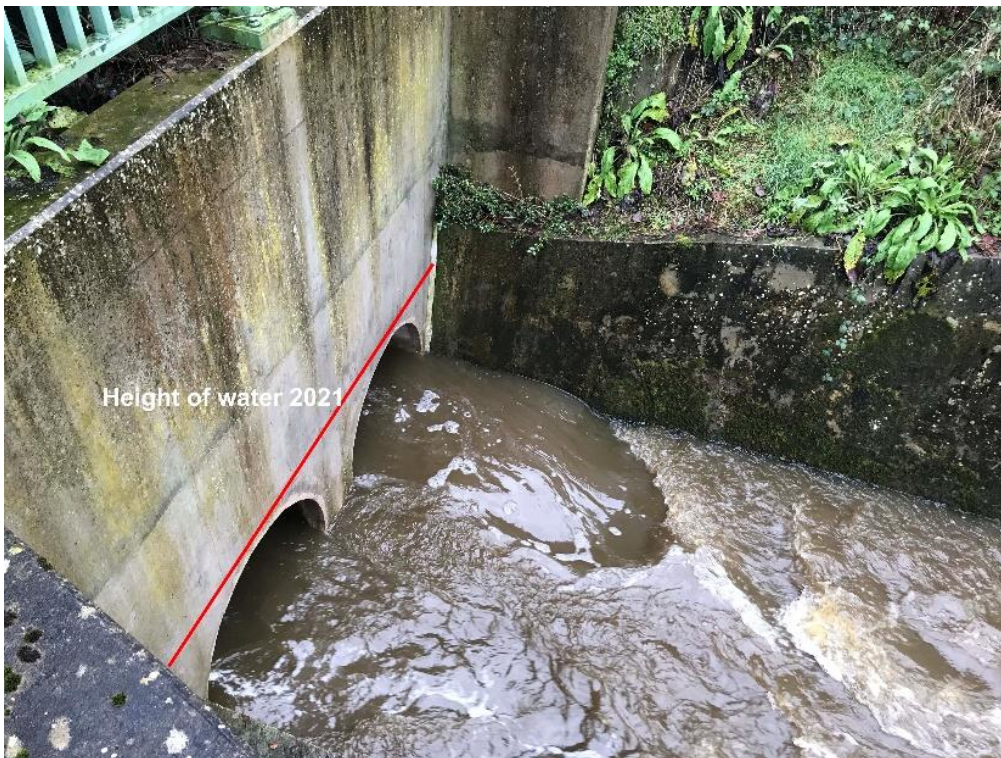
*Figure 6 Mill Brook culvert Newall Close entry 28-01-2021*

The Mill Brook downstream of the High Street runs in a deep, open culvert then enters 2 pipes 1.2m diameter, approximately 20m long, under Newall Close ([Figure 6](#)). Thereafter, the brook runs in another deep open culvert before entering a closed drain and weir behind Breen Close ([Figure 7](#)). There are 3 points on the normal course of the Mill Brook which are potential throttles; High Street bridge; pipes under Newall Close; weir behind Breen Close.

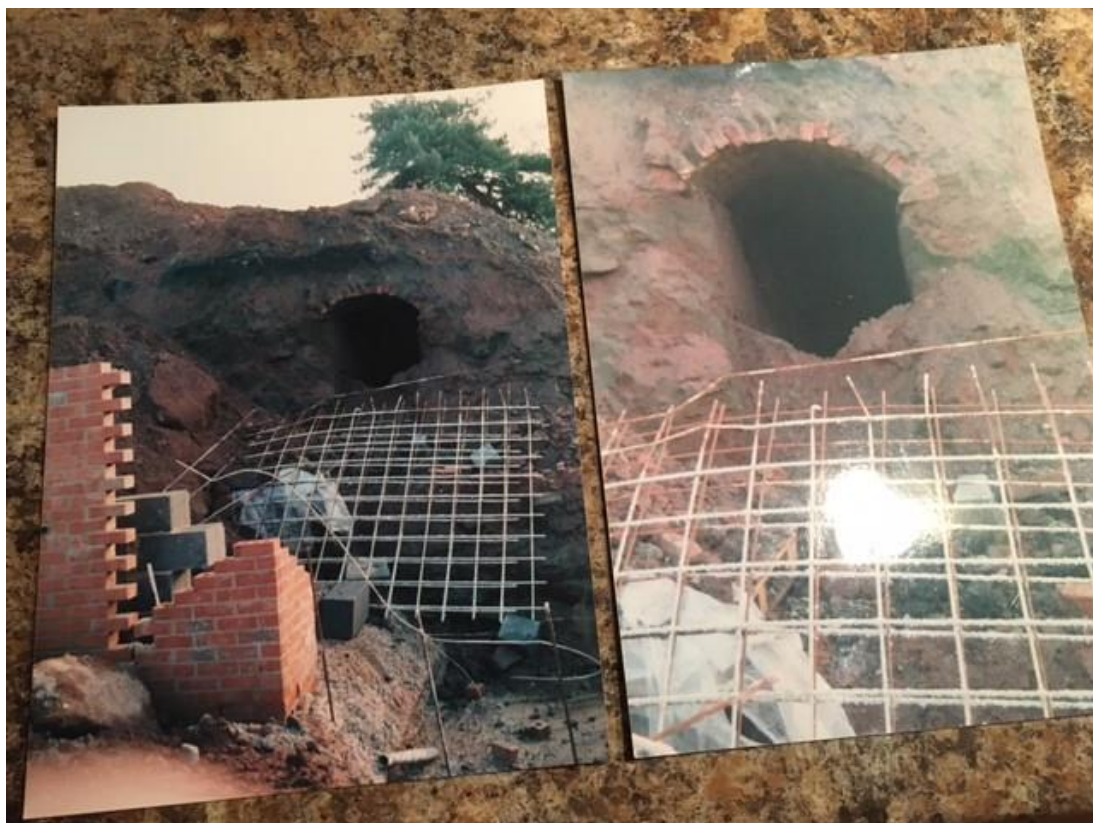
Figure 9 Drainage site of Calypso works provided by site manager 2001

Water drainage from Old Mill Place was historically an open watercourse (the millstream) passing under the High Street ([Figure 9](#)). With the construction of Breen Close in the 1990s the stream was partially replaced by an enclosed drain whose outfall is into the Mill Brook. With the Old Mill Place construction, the ancient brick and stone-lined mill race from the mill pond was closed off ([Figure 10](#)). At the same time the millstream was replaced by a drain which now normally takes surface water from the properties, the car park and, on occasion, water from a borehole in the carpark.

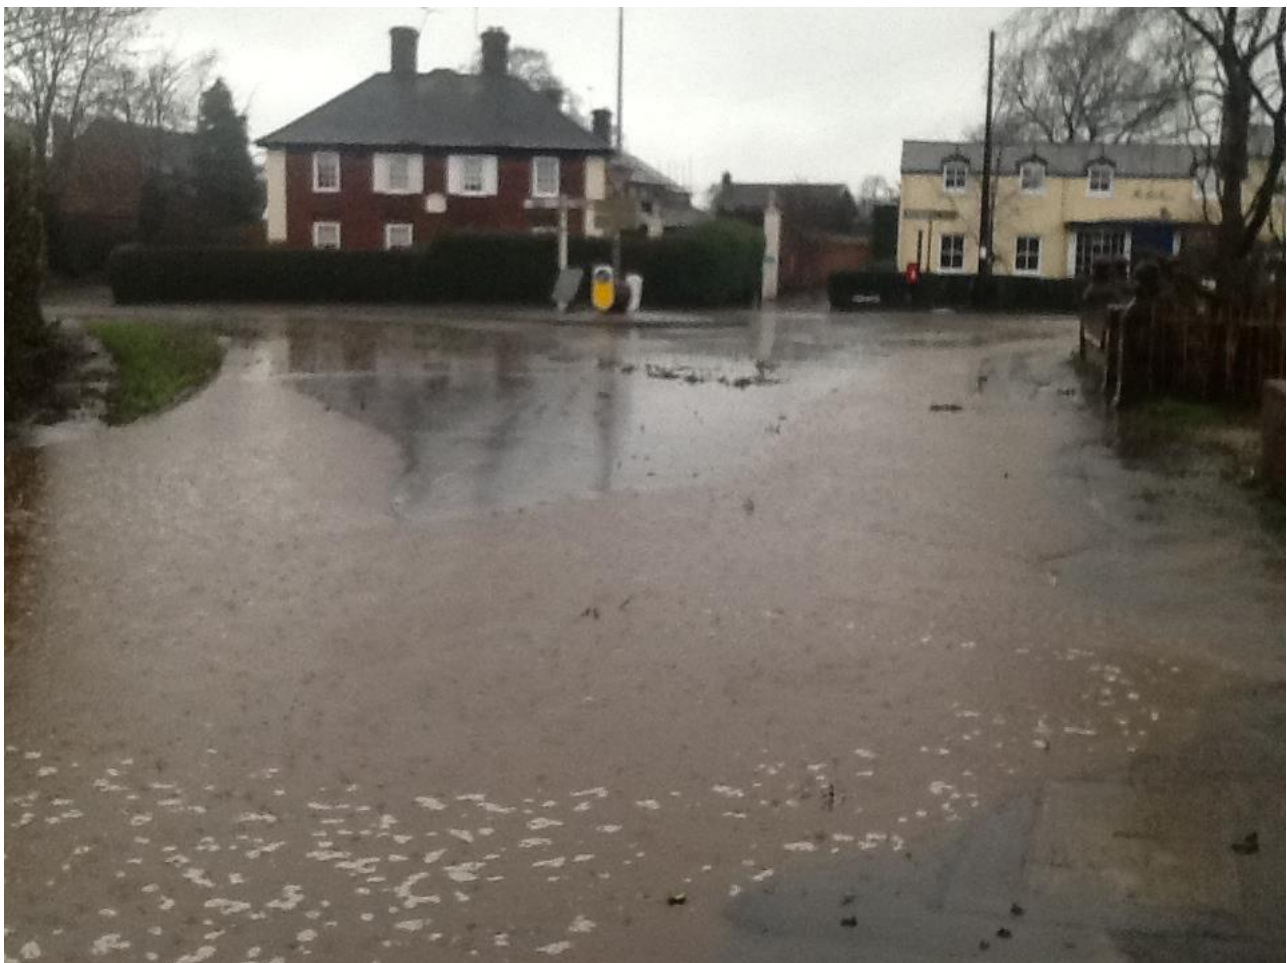
*Figure 14 High St. - Rocky La. junction 21-01-2021*

Unique to the flood of January 2021, large amounts of water flowed into the High Street on the south-western side of Old Mill Place. Some of this water, from Bolesworth Road and Rocky Lane, flowed westwards along the High Street away from the village centre and into Rosemary Row, Covert Rise, Frog Lane and the retirement village ([Figure 14, Figure 15, Figure 16](#)). No properties were flooded in this part of the village, but sand-bagging was required. Large volumes flowed in the other direction, joining water flooding out of Tattenhall Centre, a former school, ([Figure 17](#)) towards the village centre. This water drained both into Old Mill Place and directly into Mill Brook immediately beyond the bridge. Flood water on this scale has not been witnessed previously suggesting that there is problem of water run-off from fields or the road drainage or a combination of both.
