# TECHNICAL LETTER REPORT FOR GROUND INVESTIGATION

## TATTENHALL WAR MEMORIAL, HIGH STREET, TATTENHALL CHESHIRE, CH3 9PT

| <b>Reference:</b> | TE1579-TE-00-XX-RP-GE-001-V01 | <b>Author:</b> | Eve Rowland |

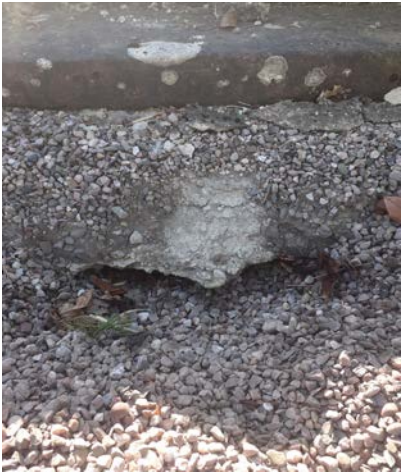
Photo 1. "Sinkhole" at surface before excavation

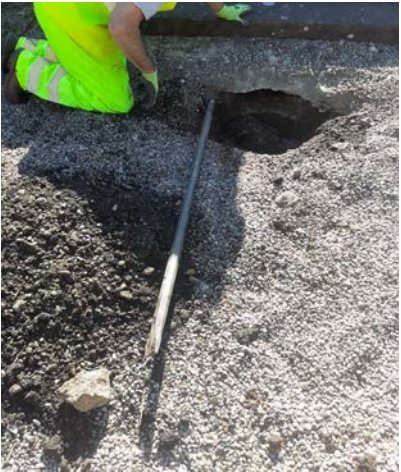
Photo 3. Pinch Bar positioned at the edge of foundation

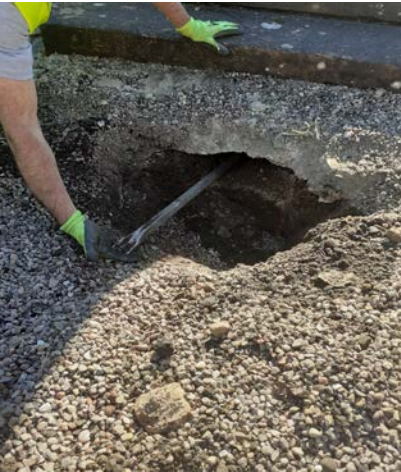
Photo 4. Pinch Bar positioned 1.10m into void space under foundation

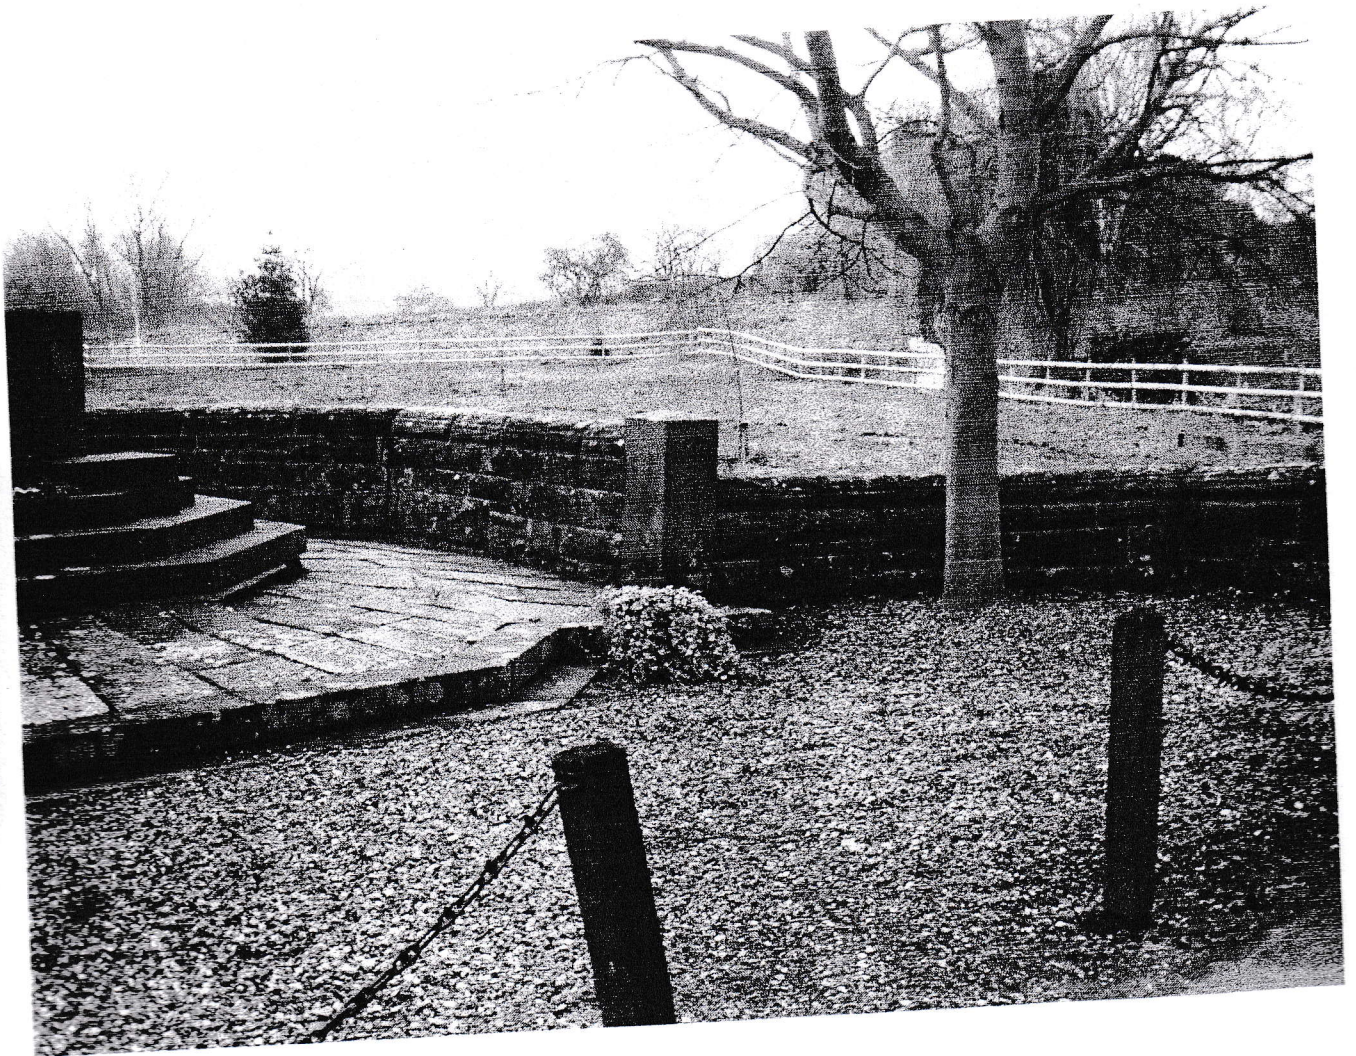
③

The surrounding pavement has settled & now falls steeply away from the centre towards the outer wall; many of the stones are loose making access hazardous – see photo 3.

The settlement appears to be progressive – note the previous joint filling & open cracks adjacent on the photographs 3,4, 5 & 6.

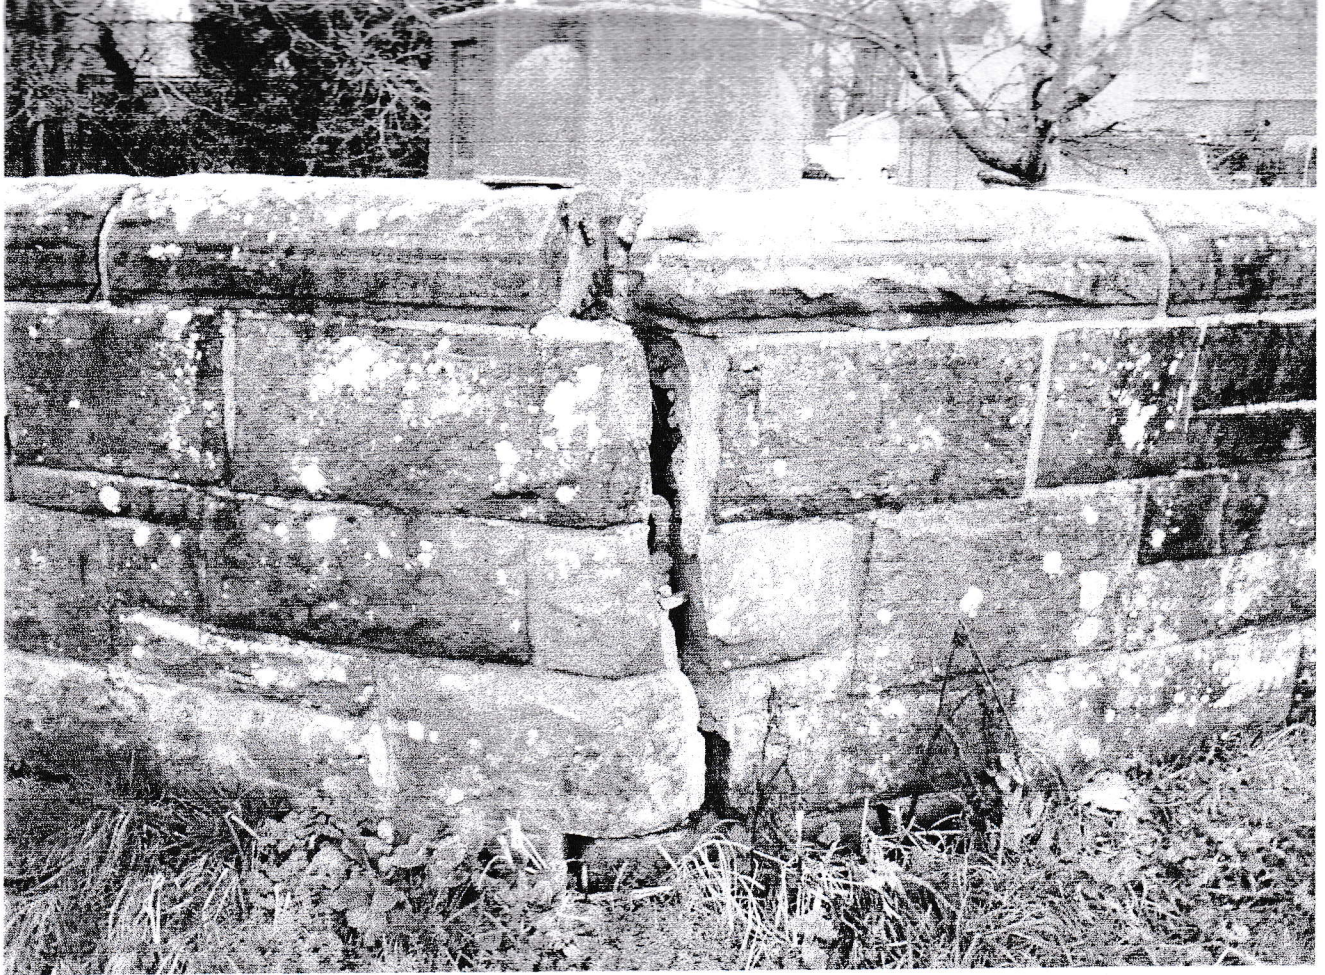
④

The surrounding walls and foundations have settled both vertically downwards & outwards (see photos 4,5 & 6 & adjacent to the trees, photo 7. There are severe splits to the angles & within the short lengths of wall between.

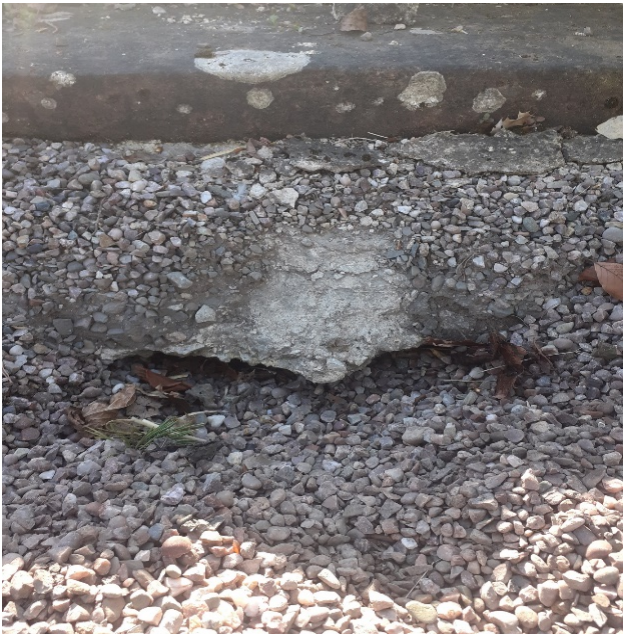
| <i>Photograph 1 - Sinkhole<br/>present at the front of<br/>the Memorial</i> | | | |

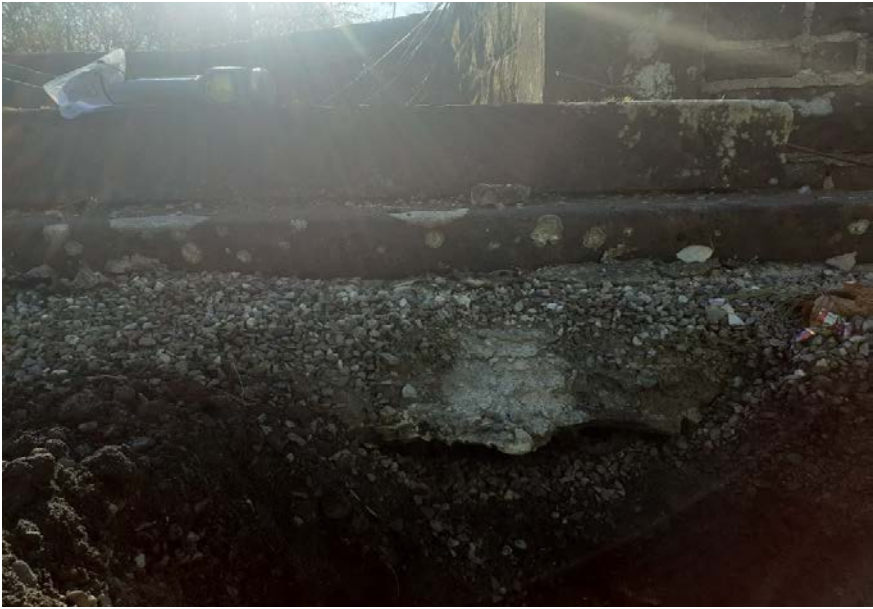
Hand dug pits were targeted along the front of the memorial to investigate the sinkholes which have appeared and the foundations of the memorial. Significant voids were encountered in the hand dug pits, specifically in HDP1 and HDP2 extending from the pit beneath the concrete slab foundation of the memorial. A Schematic cross section of HDP is attached in Appendix A (TE1579-TE-00-XX-DR-GE-001-V01-Foundation Inspection Pit (HDP1)) which highlights the void space underneath the memorial.

It was evident during the hand pitting that there was a void beneath the foundation, this could have been due to long term settlement of the construction layer into the Peat and/or partial washout of soil over time due to high groundwater levels and flooding events.

| <i>Photograph 2 - Void<br/>under existing<br/>foundations at a<br/>sinkhole (HDP02)</i> | | | |

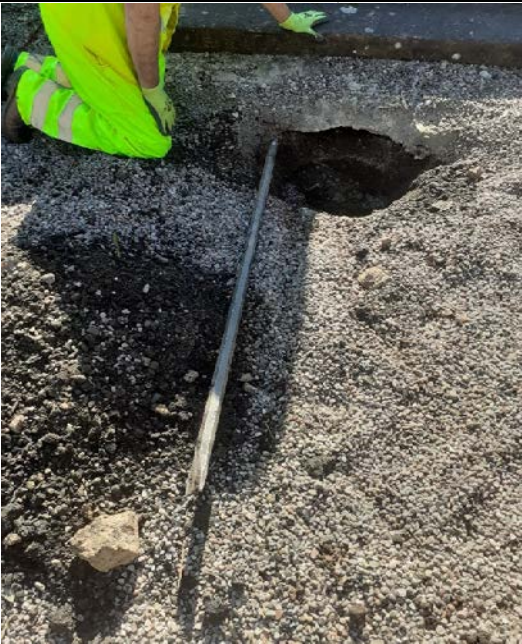
The ground investigation demonstrated that the foundation of the Memorial is a thin concrete ground bearing slab as shown in Photographs 1 to 4 within Appendix E.

| <i>Photograph 3 - HDP01<br/>with Pinch Bar placed at<br/>the edge of existing<br/>foundation</i> | | | | | |

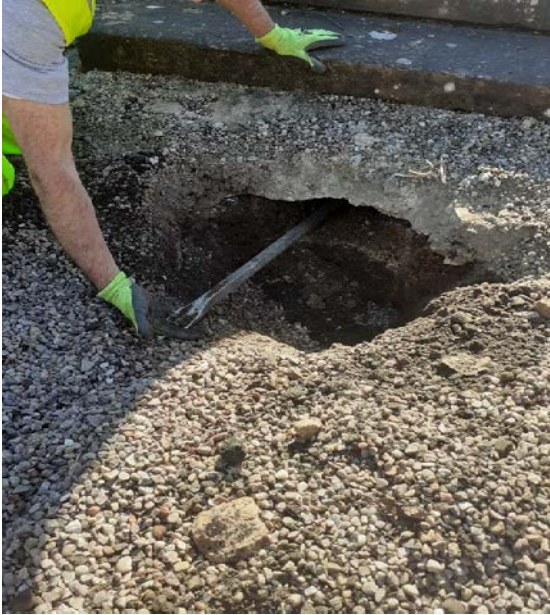
| <i>Photograph 4 - HDP01<br/>with Pinch Bar inserted<br/>into void beneath the<br/>foundations (1.10m)</i> | | | | | |

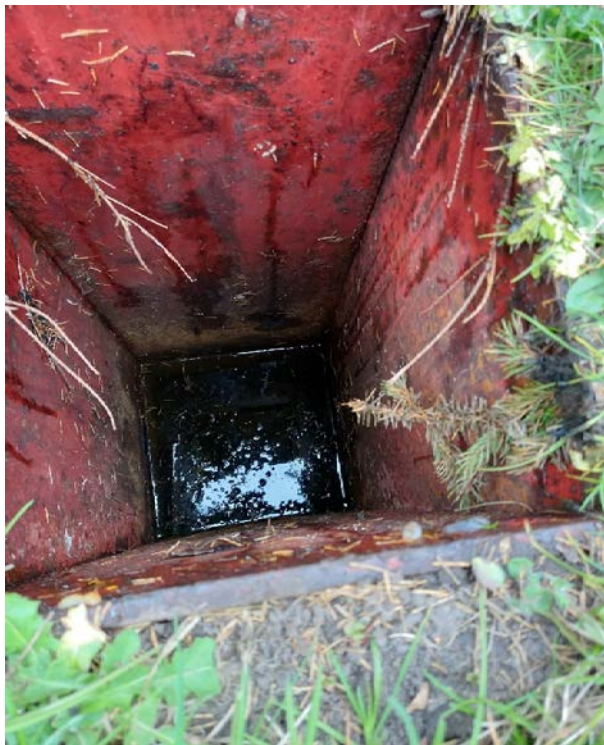
Immediately to the north of the Memorial is a potential soakaway or drain (see photograph 5 in Appendix E), it is unclear at what its function is into the surrounding area. The groundwater within it was approximately 0.80m below ground level at the time of the site walkover.

| <p>Photograph 5 -<br/>Groundwater level at<br/>0.80m bgl shown by<br/>existing potential<br/>soakaway/drain in close<br/>proximity to the Site (off-<br/>Site between the drainage<br/>ditch and brook)</p> | | | |

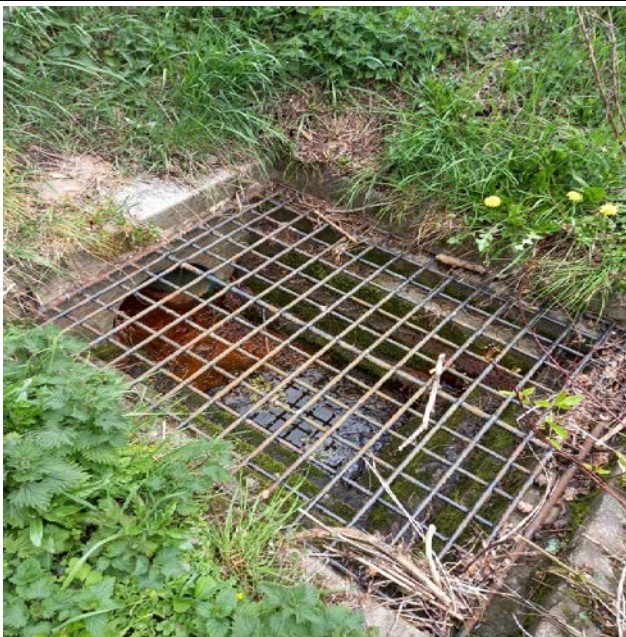
Directly adjacent to the south of the Site is an overflow drain which assists the Mill Brook during flood events. This drain runs northwest underneath the road parallel to the Mill Brook (drains into the Brook) and was installed circa 2003. During the site walkover, the drain shows evidence of seepage of water coming through the concrete structure in the northern face, adjacent to the Site (see Photograph 6 in Appendix E). During the walkover it was evident that the wall above the diversion drain is also showing evidence of differential settlement, this would be in keeping with the current ground conditions and groundwater level.

The construction of this diversion drain could potentially create a preferential pathway for sediment to be partially washed out.

| <p>Photograph 6 - Diversion<br/>drain adjacent to Site</p> | | | |

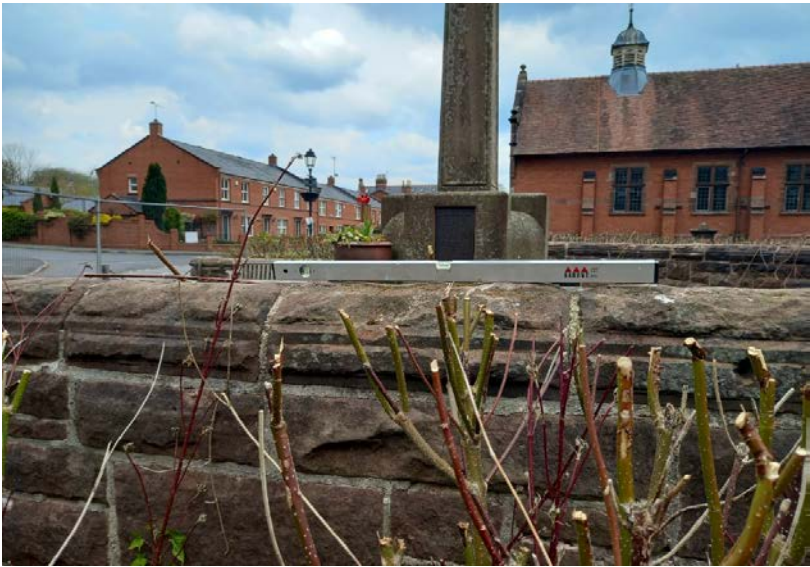
This is shown as the footings of the Memorial are not level and are dipping towards the road and towards the Mill Brook. There is evidence that there are a number of cracks within the mortar of the surrounding wall of the Memorial have been identified (See photograph 10 in Appendix E).

| Photograph 7 -<br>Surrounding wall of<br>memorial dipping towards<br>the road due to<br>subsidence | | | |

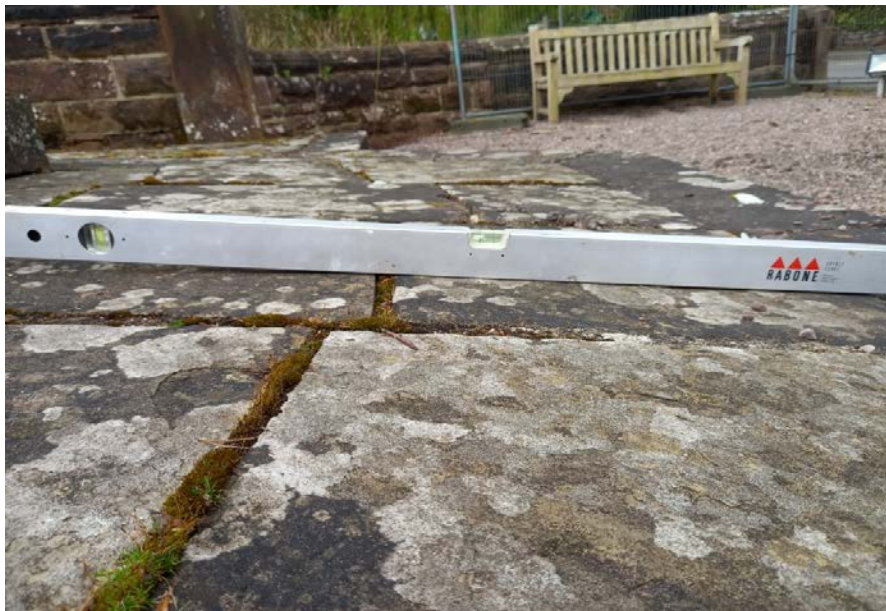
| Photograph 9 - Dip of the memorial towards the road and drain due to subsidence | | | | |

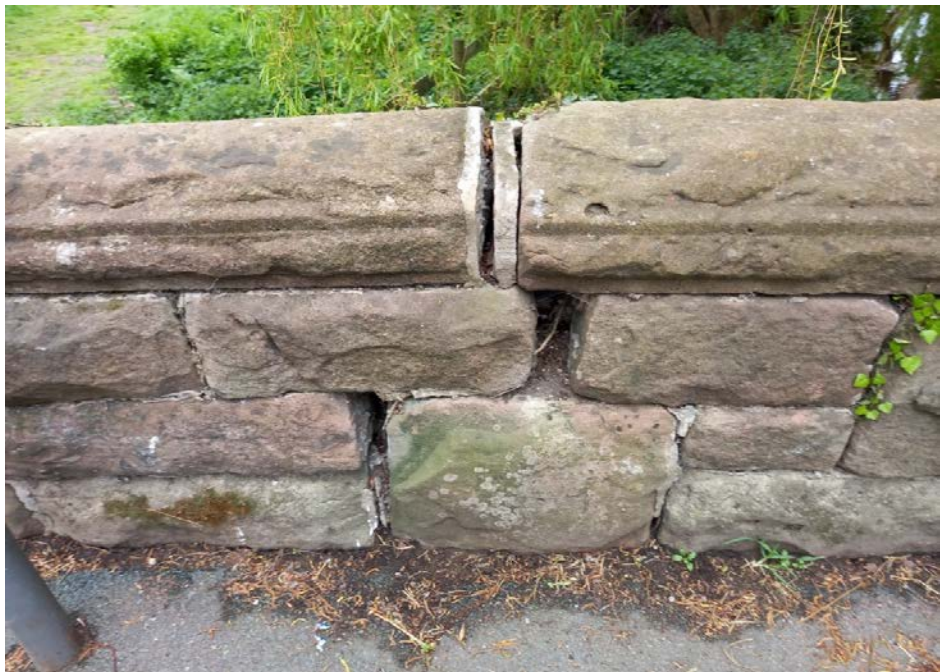
Due to the extremely low strength of the Peat, this is deemed the primary driver for the differential settlement seen historically in 2004 with Graham Holland Associates Report and the recent issues with the Memorial.

| Photograph 10 - Damage to surrounding walls of the Site due to subsidence | | | | |

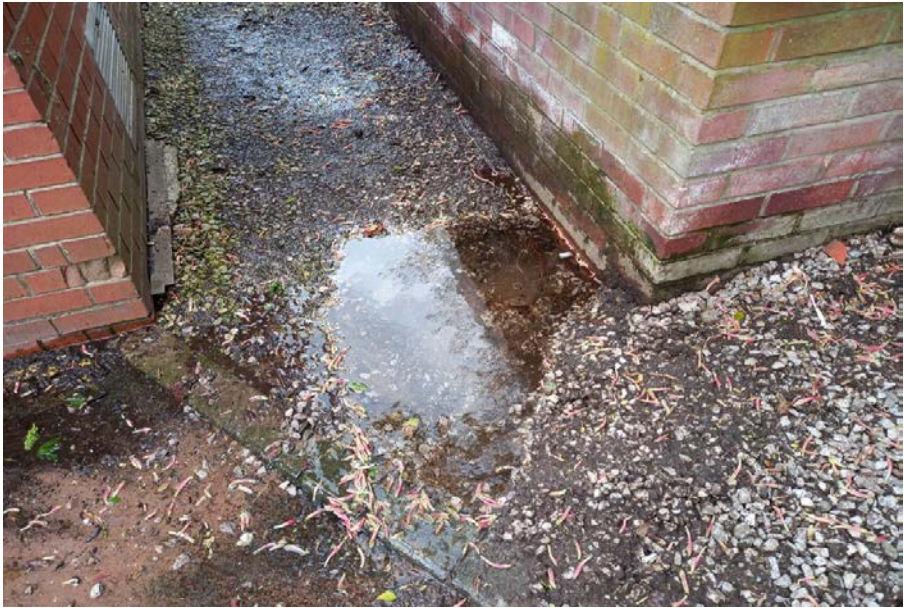
Located approximately 30m east of the Site (to the rear of the Barbour Institute) is a groundwater borehole. This borehole is at a lower elevation (approximately 1.00m) than the Site itself but shows evidence of sub-artesian groundwater leaking through the brick surroundings. The car park in which this borehole is located had water covering it; the caretaker of The Barbour Institute has informed Tier Environmental (conversation had whilst on Site) that this car park has not fully dried out for approximately 9 months, and the borehole has been leaking at least since then. This is another line of evidence showing the high groundwater levels are potentially affecting the War Memorial.

| <i>Photograph 11 - Water seeping from well behind the Barbour Institute due to high groundwater</i> | | | |
