Notes of Flood Response Working Group Meeting Held via Zoom 10th March 2021

Notes of Meeting with Environment Agency Representatives & CW&C Held via Zoom 2nd March 2021

Jan 2021 post-flood observation

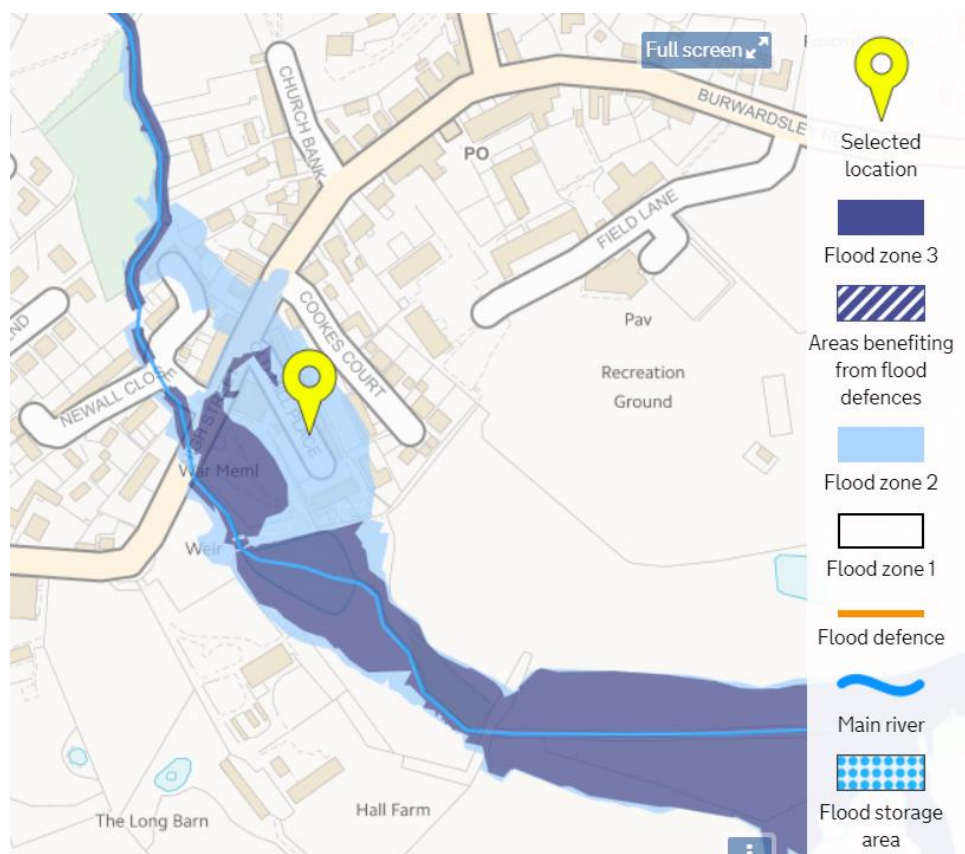
Flood Risk Management Map

When Old Mill Place was last reviewed the flood risk was reduced for zone 3 to zone 2 (see attached map) which is lower risk. It was confirmed the rating and map would be subject to review.

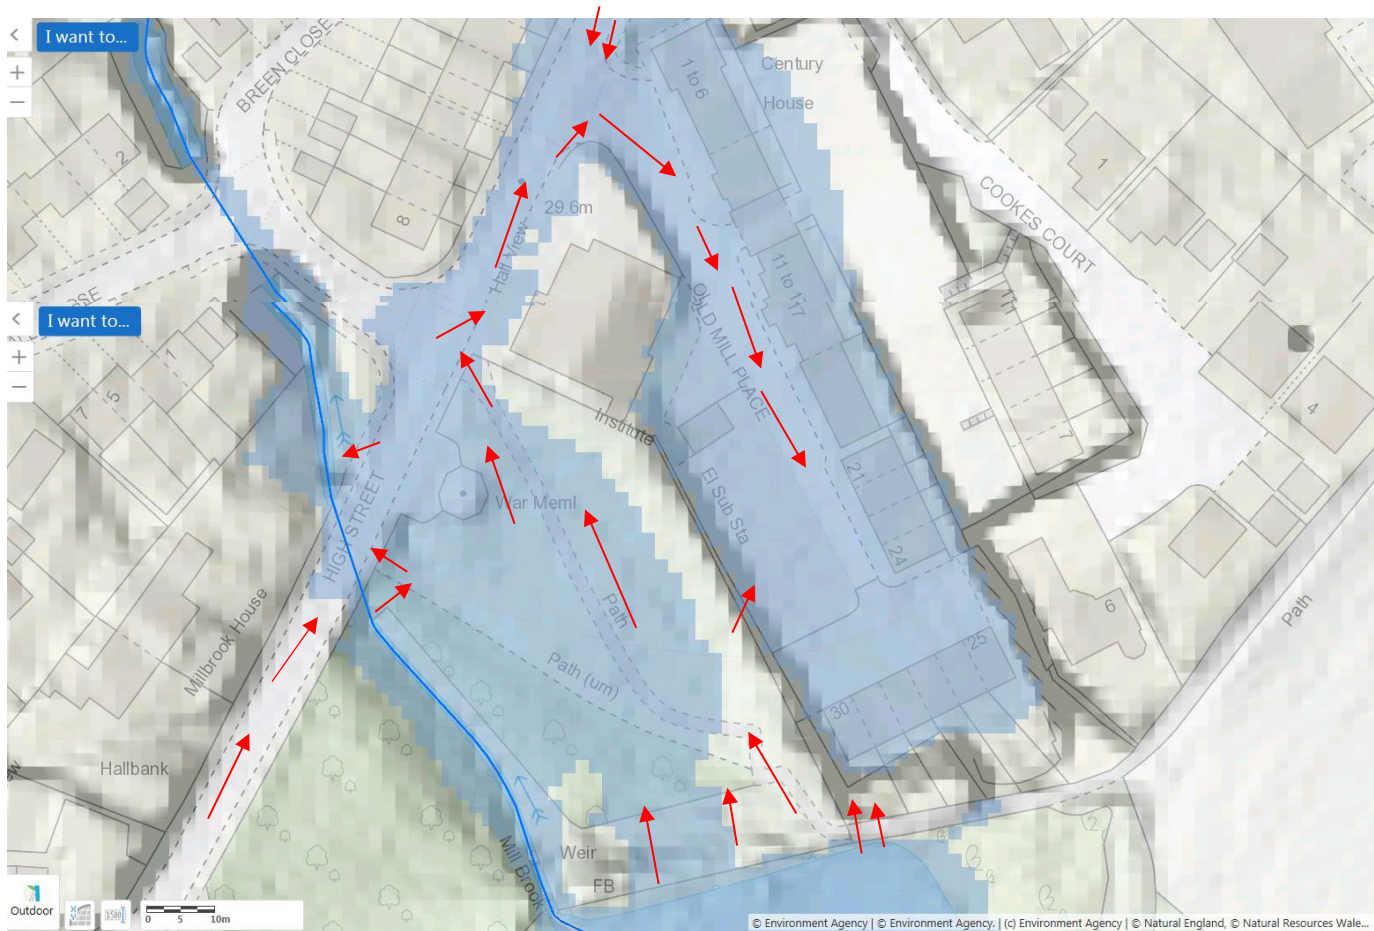
Red arrows = flood route.

Water over topped the Old Mill Pond dam, and affected properties in the back of old Mill Place.

The main issue appears to be with the conveyance capacity of the culverts that take Mill Brook under the High street.

Downstream levels in Mill Brook were not observed to be limiting, although they were observed to be high.

The observed flood wrack shows back up in the war memorial park, spilling onto the high street and down into Old Mill Place. There was also a direct route over the dam.

Water exits on to the High street via the gap in the stone wall by the brook and via the gateway in the bottom corner of the memorial park. It then goes down the High Street, past the institute and flows down into the Old Mill Place low spot. Surface water also flows from the North down the High Street into Old Mill Place. Residents reported that on this event, surface water also flowed along High street from the south. Surface water exit from Old Mill Place is further hampered by the Old Mill race having been culverted and reportedly replaced with a 300 mm pipe. This will not aid the evacuation of surface water from this point.

Footpath raising along here, would prevent this flood route, although this would need to be done in conjunction with some minor ground raising between the park and old Mill Place.

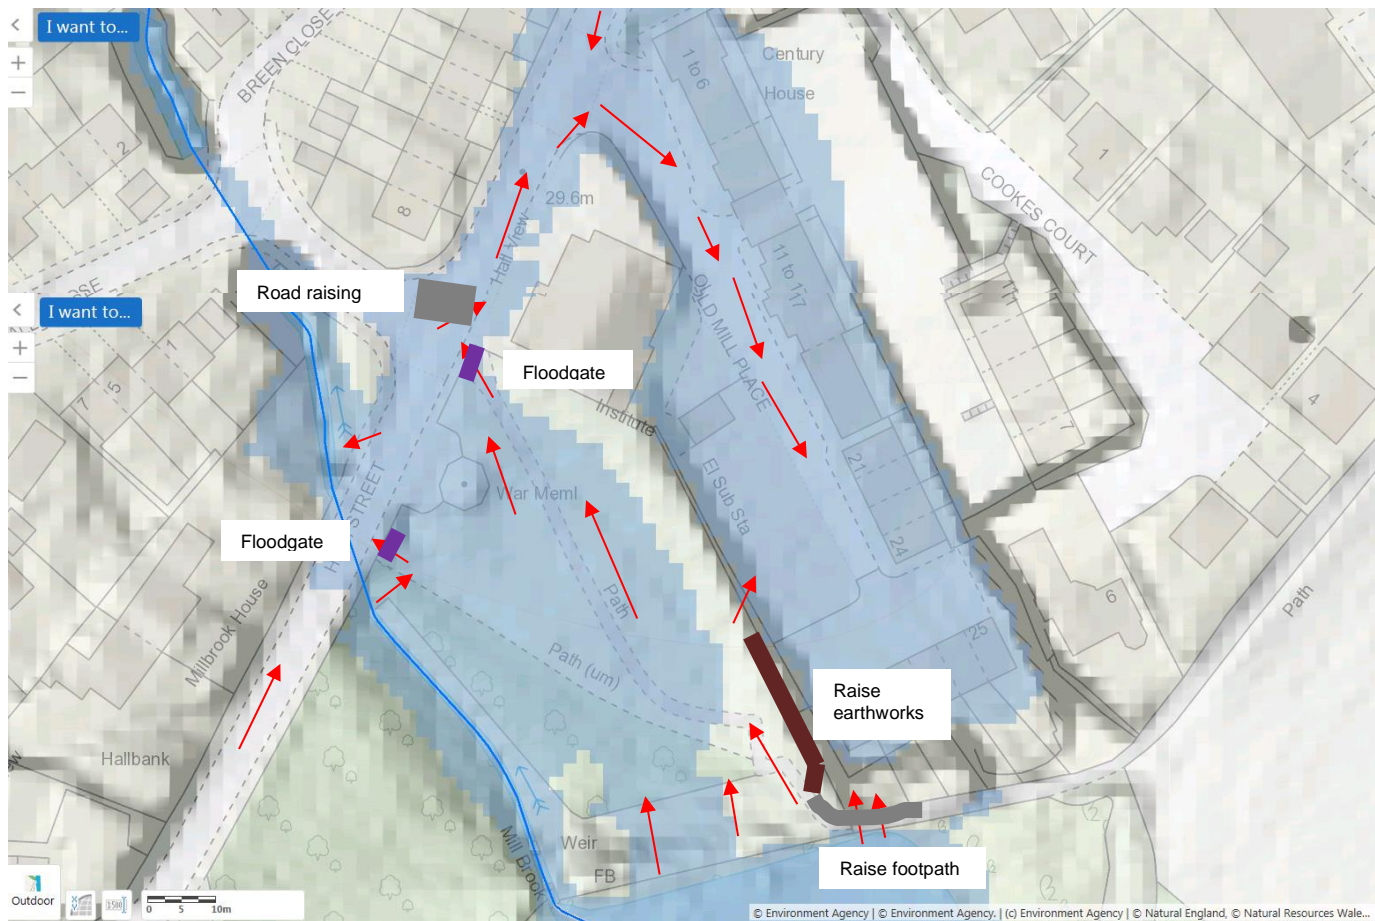
Possible interventions
Upstream NFM
Localised ground raising

Further containment in the park is problematic as the walls are not to flood standards and may fail with more load on them. But the potential for earth raising round the park remains.

This does not solve the surface water issue though, with water running down the road from the village centre from the north (and south) into Old Mill Place. Flooding could still occur from this route.

Although without the main river flows, these may be manageable.

The fluvial route could be improved by containment in the park.

Raising of the footpath by the dam. This will be required, whatever the other solution, as there is direct overtopping from the dam to this point. Given the risks of dam fail, further raising of the dam is not an option.

This would need to be accompanied by earthworks downstream to contain the water within the park, and keep out a direct flood route from Old Mill Brook.

Road raising on the High street could have the same desired effect of containment.
