# Tattenhall Interim Report Details

Project:	Storm Christoph Section 19 Interim Report				
Area:	Tattenhall				
Date:	04/10/2021	Project No.:	5150735

# Tattenhall Interim Report

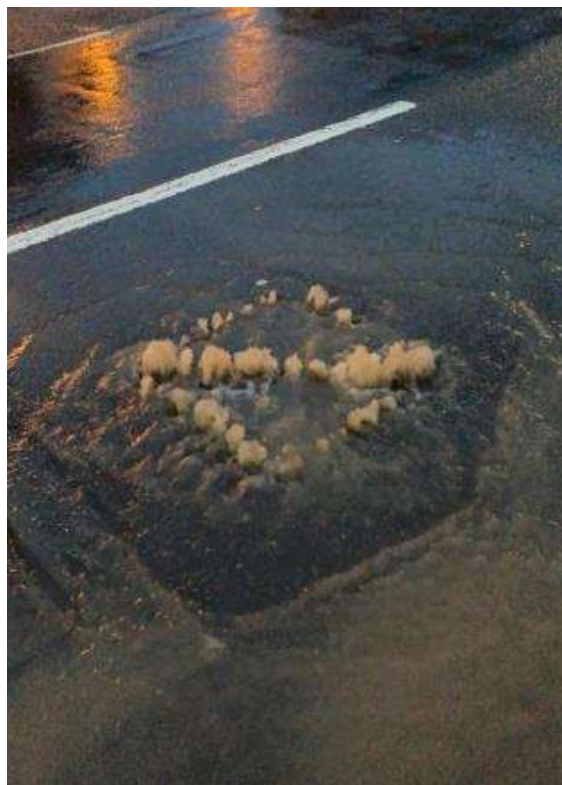
**Figure 2 - High Street manhole cover opposite Old Mill Place. 20/01/21**

- High Street covers for surface water drainage were lifted indicating the capacity of the culvert had been surcharged.
- The car park at Old Mill Place currently has a layer of mossy sludge that has been there for several weeks, it is thought that this is related to high groundwater. Similarly, there are concerns regarding the borehole being capped which may again lead to increased groundwater levels.

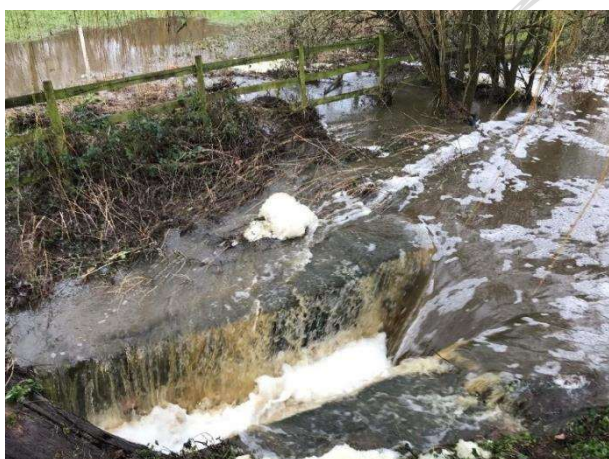
**Figure 3 - Mill Brook at the High Street Bridge. 20/01/21**

Flooding affected the car park of the Barbour institute and the land between the Barbour institute and Mill Brook, including the flooding of the Grade II Listed war memorial. It was reported that where Mill Brook is culverted under the High Street, water overflowed the storm drain before flowing overland past the war memorial to the Barbour Institute.

- Outside of the Section 19 investigation, CWaC and the EA are consulting regarding the management of issues associated with the legacy borehole.
- The Parish Council report that there are 3 points on the normal course of the Mill Brook which are potential throttles; the High Street bridge; the pipes under Newall Close; the weir behind Breen Close.

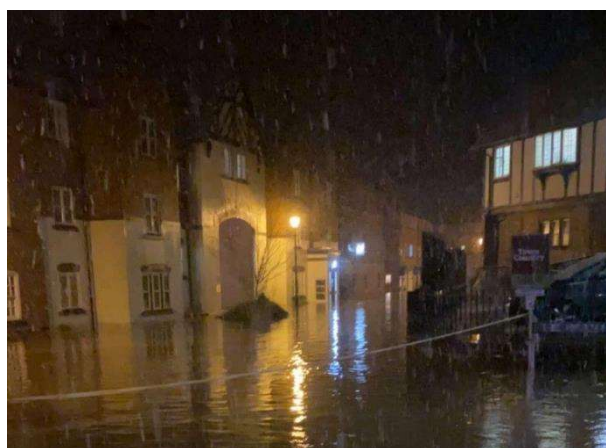
**Figure 4 - Old Mill Place. 20/01/21**

The High Street at the entrance to Old Mill Place is a low point for the road as well as for the surface and foul water drainage systems. During Storm Christoph, large volumes of water entered from both directions of the High Street into this low area. It was also reported that water overtopped the Mill Pond and ran into Old Mill Place in the South East corner. Residents reported water surcharging from the drainage network and coming up from the ground.
