# the play inspection company

## **Operational Inspection**

Tattenhall & District Parish Council

Tattenhall Park

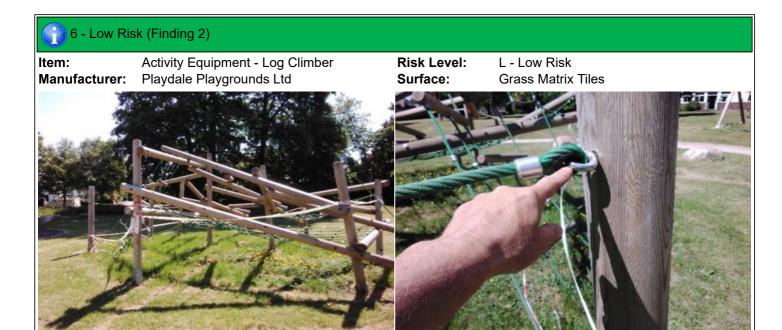
Finding: A number of fixing(s) have worked loose

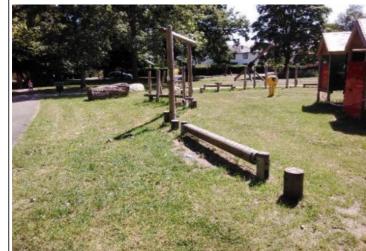
# 6 - Low Risk (Finding 7)

Item:Activity Equipment - Adventure TrailRisk Level:L - Low RiskManufacturer:Playdale Playgrounds LtdSurface:Grass
