## **Submission to assist Cheshire West & Chester investigation of the significant flooding event 20<sup>th</sup> January 2021**

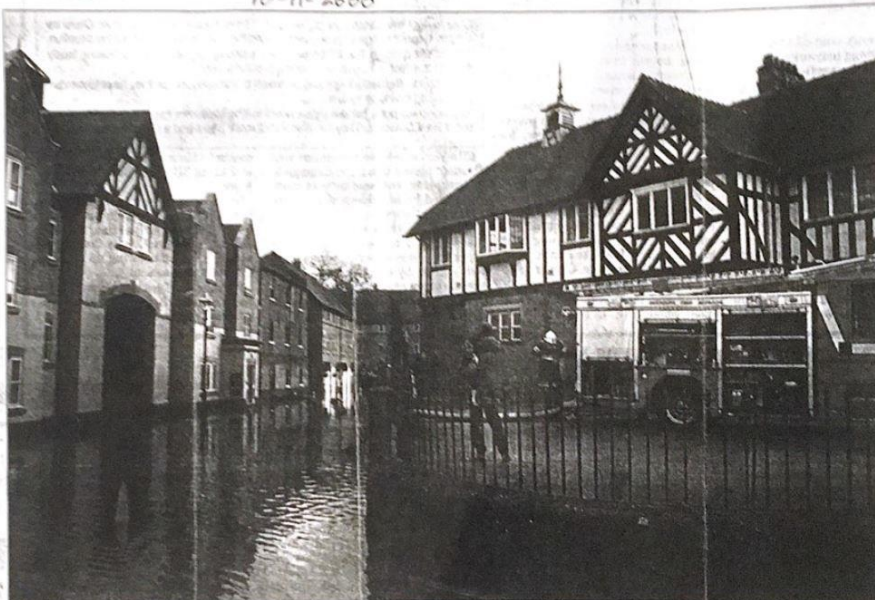
DEVASTATION: Cheshire firefighters battle to pump the floodwater out of Mill Place in Tattenhall. 7564H30 PICTURE by HAYDN IBALL.
