# TECHNICAL LETTER REPORT FOR GROUND INVESTIGATION

## TATTENHALL WAR MEMORIAL, HIGH STREET, TATTENHALL CHESHIRE, CH3 9PT

| <b>Reference:</b> | TE1579-TE-00-XX-RP-GE-001-V01 | <b>Author:</b> | Eve Rowland |

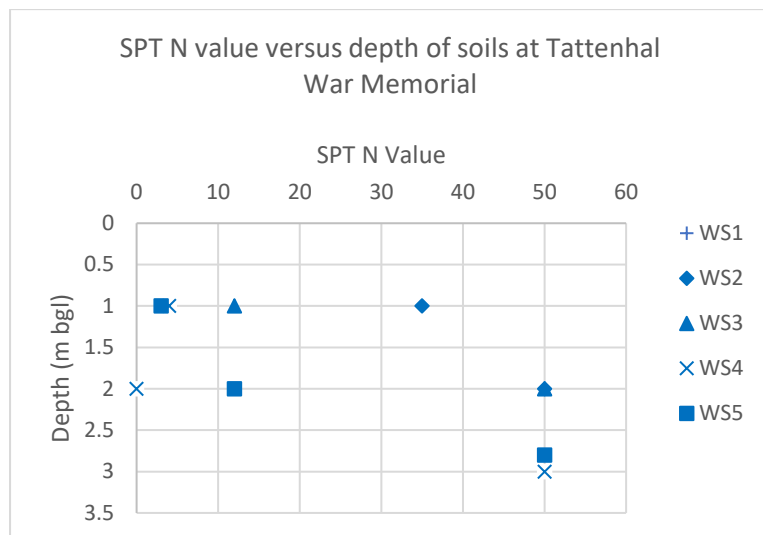
**Figure 5.2.** SPT N Value versus depth

*In situ* Geotechnical testing was conducted in all Window Sample boreholes. SPT tests were conducted every meter in the borehole. Figure 5.1 below outlines SPT results versus depth.

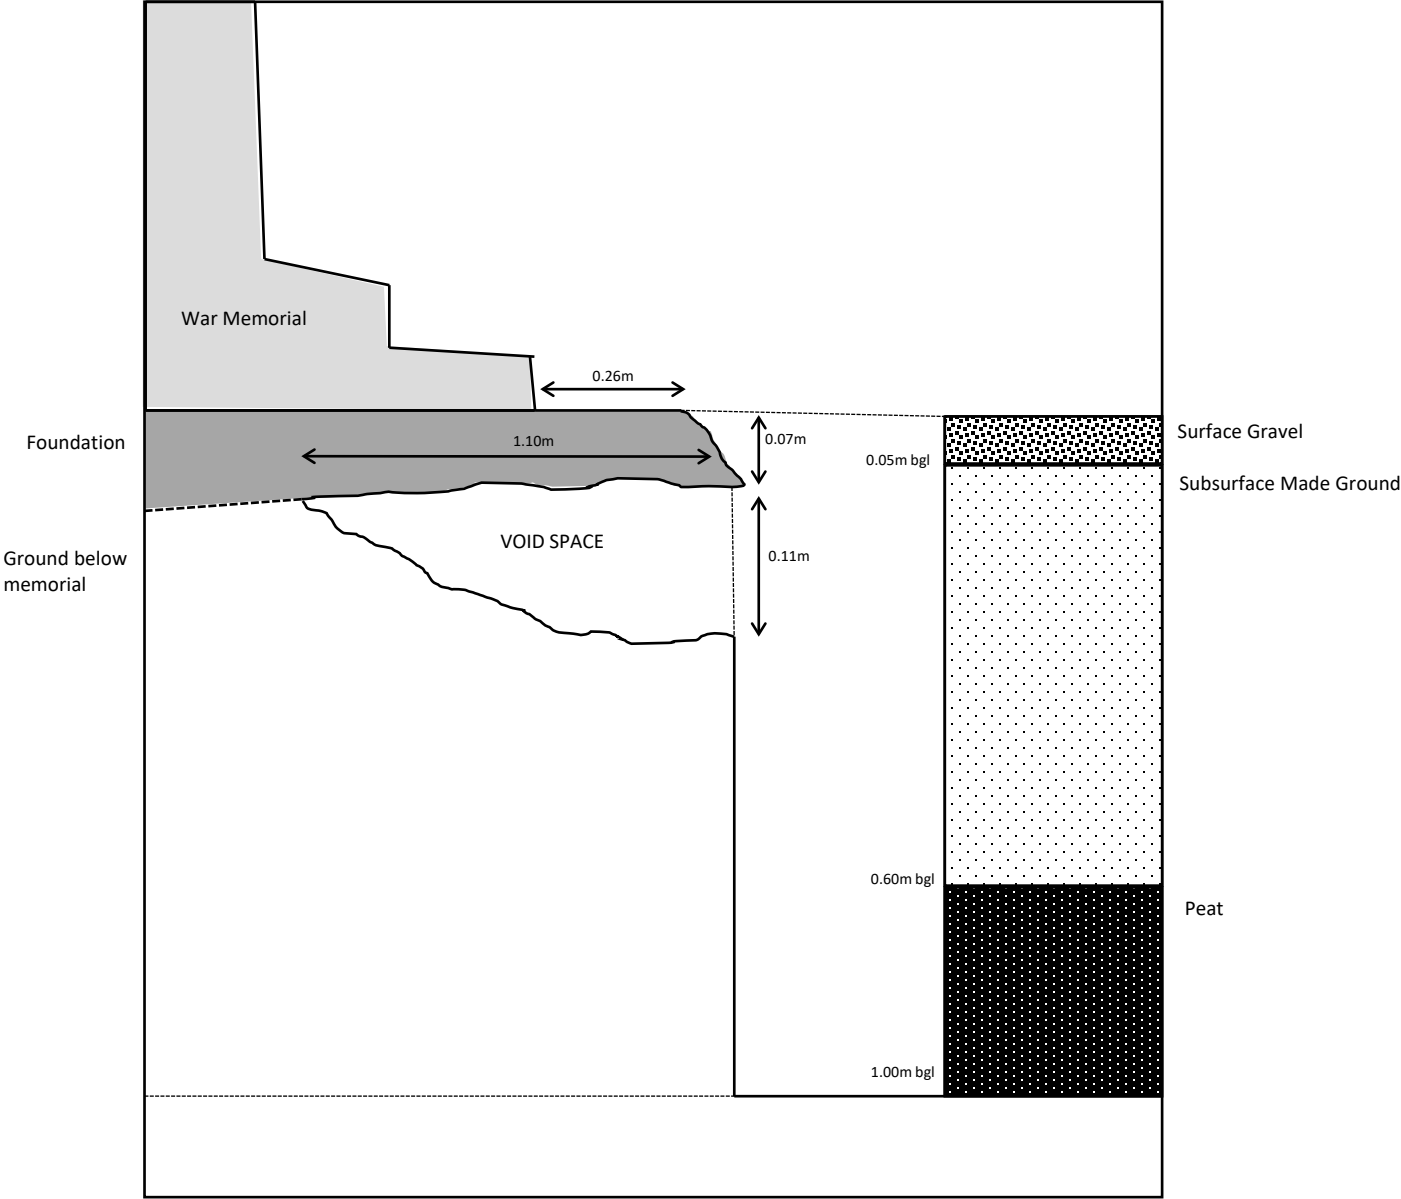
TE1579: Tattenhall War Memorial – HDP1 (foundation inspection pit)

Photo 1. "Sinkhole" at surface before excavation

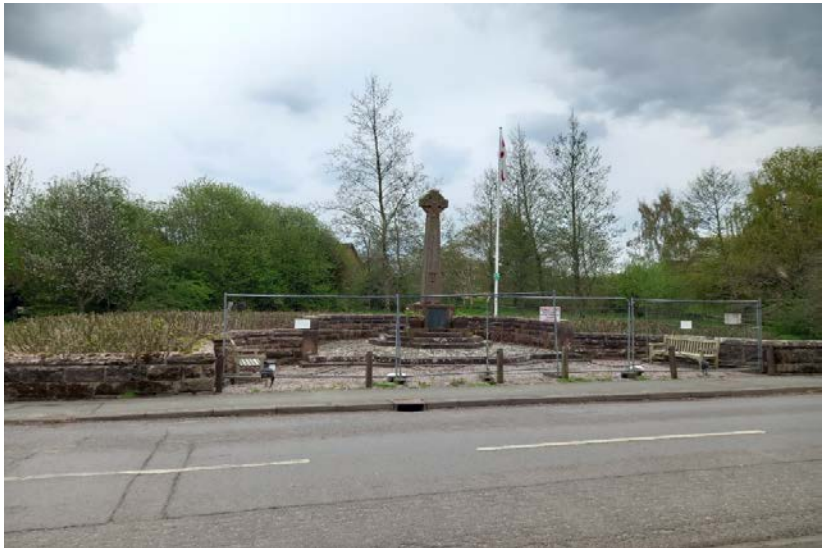
- It is possible that potential impact from passing traffic could contribute to the differential settlement and damage to the Memorial.
- The foundation slab is thin (0.07m) and not sufficient to effectively deal with the Peat ground conditions it was constructed on. Previous evidence in 2004 of the wall being repaired contributes to this with the current evidence of cracking of mortar joints on the Memorial and wall.

| Photograph 8 - Overview<br>of Site showing proximity<br>to the road | | | |

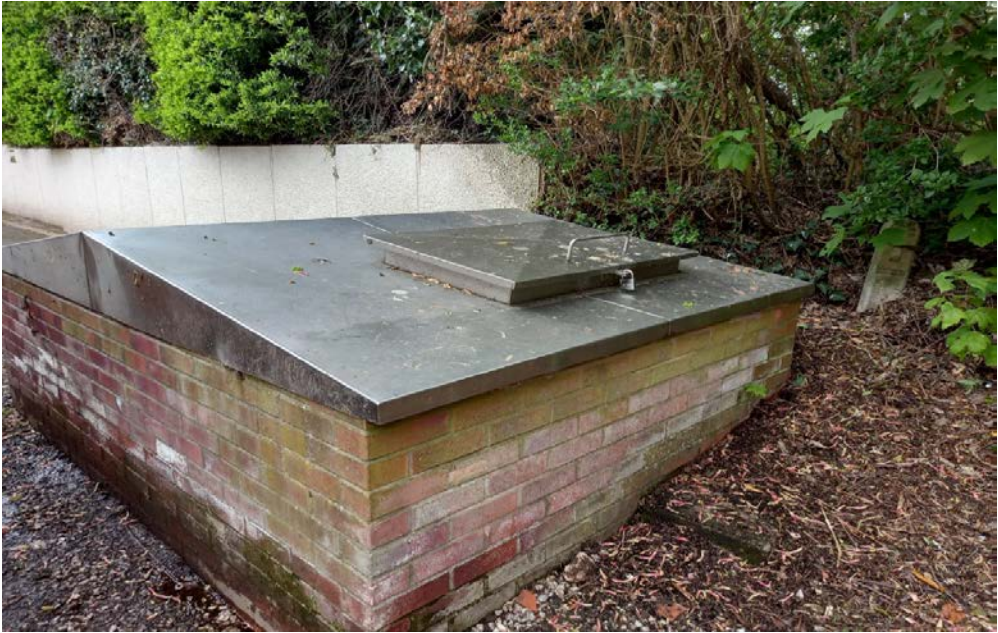
Located approximately 30m east of the Site (to the rear of the Barbour Institute) is a groundwater borehole. This borehole is at a lower elevation (approximately 1.00m) than the Site itself but shows evidence of sub-artesian groundwater leaking through the brick surroundings. The car park in which this borehole is located had water covering it; the caretaker of The Barbour Institute has informed Tier Environmental (conversation had whilst on Site) that this car park has not fully dried out for approximately 9 months, and the borehole has been leaking at least since then. This is another line of evidence showing the high groundwater levels are potentially affecting the War Memorial.

| <i>Photograph 12 - Well behind the Barbour Institute</i> | | | |
